# UNDERWATER BRIDGE INSPECTION REPORT

# STRUCTURE NO. 2723

# CSAH NO. 153 (LOWRY AVENUE NORTH)

# MINNESOTA DEPARTMENT OF TRANSPORTATION UNDERWATER BRIDGE INSPECTION

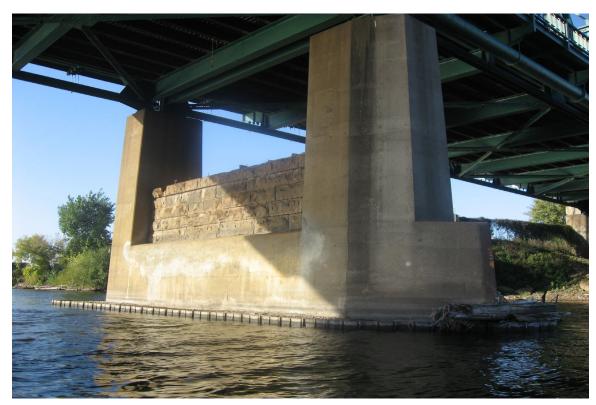
Photograph 1. View of Pier 1, Looking Southwest.

- A moderate accumulation of timber debris consisting of logs and branches 1 to 2 feet in diameter and smaller was observed at the upstream nose on top of footing of Pier 1. The debris extended from the channel bottom up 3 feet and was 20 feet long.

- (A) Remove the accumulation of timber drift and debris around the upstream end of Pier 1.
- (B) Reinspect the submerged substructure units at the normal maximum recommended (NBIS) interval of five (5) years.

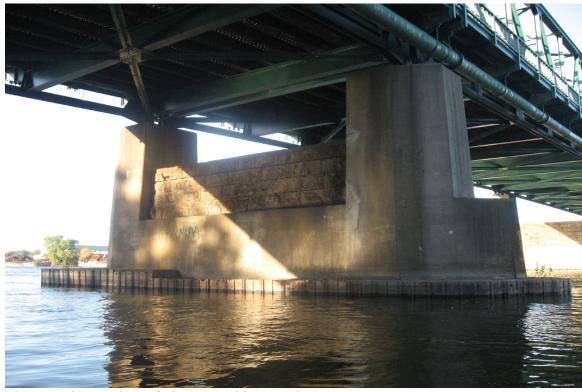
Photograph 6. View of Pier 4, Looking Southwest.

- An 8 inch high band of heavy scaling was observed along the pier shaft at the top of the footing that extended approximately 30 feet and exhibited up to 2 inches of penetration and exposed reinforcing steel on the west side of Pier 4. There was up to 4 inches of penetration and exposed reinforcing steel on the east side of Pier 4.

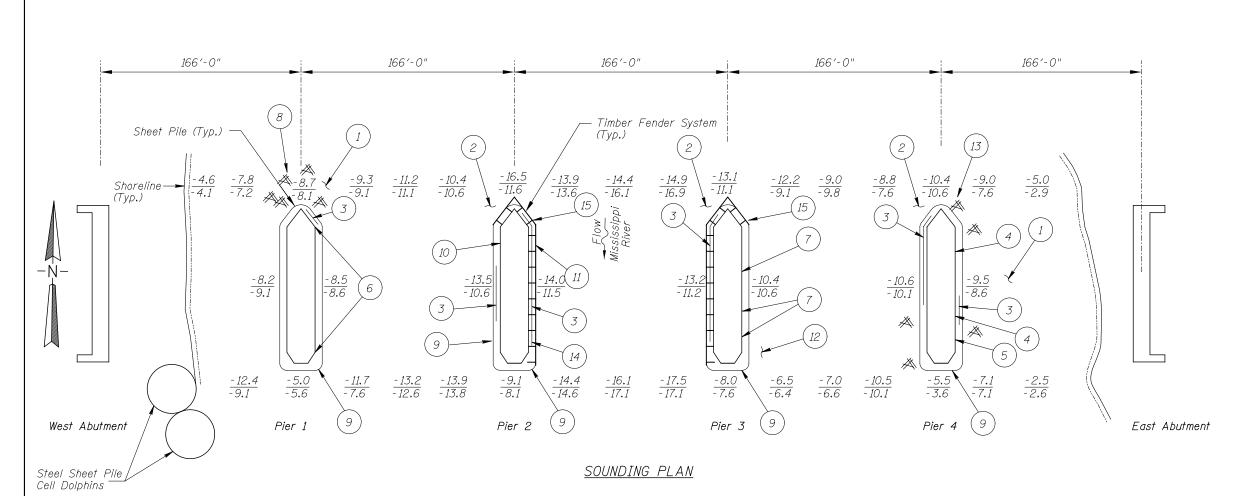
INSPECTION AND SOUNDING PLAN

$\sim$	
(	1	The channel bottom material around Pier 1 consisted of silty sand and gravel with up to
		6 inches of probe rod penetration.

- The channel bottom material consisted of 1 to 2 foot diameter riprap at the upstream ends and sandy infilling with up to 1 foot of probe rod penetration.

- Several gaps were observed between the steel sheeting and the concrete footing up to 3 inches wide.
- The middle portion of the concrete pier shaft exhibited two vertical cracks that extended from the top of the footing to the bottom of the stone masonry. The cracks exhibited greas of section loss up to 3 inches wide with up to 1 inch of penetration.

- The middle portion of the concrete pier shaft exhibited five vertical cracks 1/16 inch wide (maximum) that extended from the top of the footing to the bottom of the stone masonry.

- The middle portion of the concrete pier shaft exhibited four vertical cracks 1/16 inch (maximum) that extended from the top of the footing to the bottom of the stone masonry.

- Typically, the top of concrete footing was heavily deteriorated within the steel sheeting with up to 1 foot penetration. The steel sheeting around each pier fully extended into the channel bottom with only light surface corrosion observed with 1/8 inch nodules.

- The middle portion of the concrete pier shaft exhibited five vertical cracks 1/16 inch (maximum) that extended from the top of the footing to the bottom of the stone masonry.

- An area of section loss was observed on the pier shaft 5 feet above the top of the footing and was 1 foot in diameter with up to 4 inches of penetration.

- A log that was 1 foot in diameter and 15 feet long was observed on the channel bottom along the downstream end of Pier 3.
- A light accumulation of timber and steel debris was observed scattered around Pier 4

- Four cracks were observed on the East side of Pier 2 extending from top of footing to the bottom of stone masonry 1/16 inch wide (maximum).
- The nose area of fender system has areas of impact damage from the waterline up 4 feet. Timber and steel show deterioration such as corrosion and checking up to 1/2 inch wide.
